STAFF REPORT

RE: **ESA DEVELOPMENT PERMIT** **Foreshore** **Watercourse** **Eagle** **Heron**

PLANNING FILE NO.: 3060-20 / DP 6D 22

Riparian Areas Regulation - Qualified Environmental Professional - Assessment Report

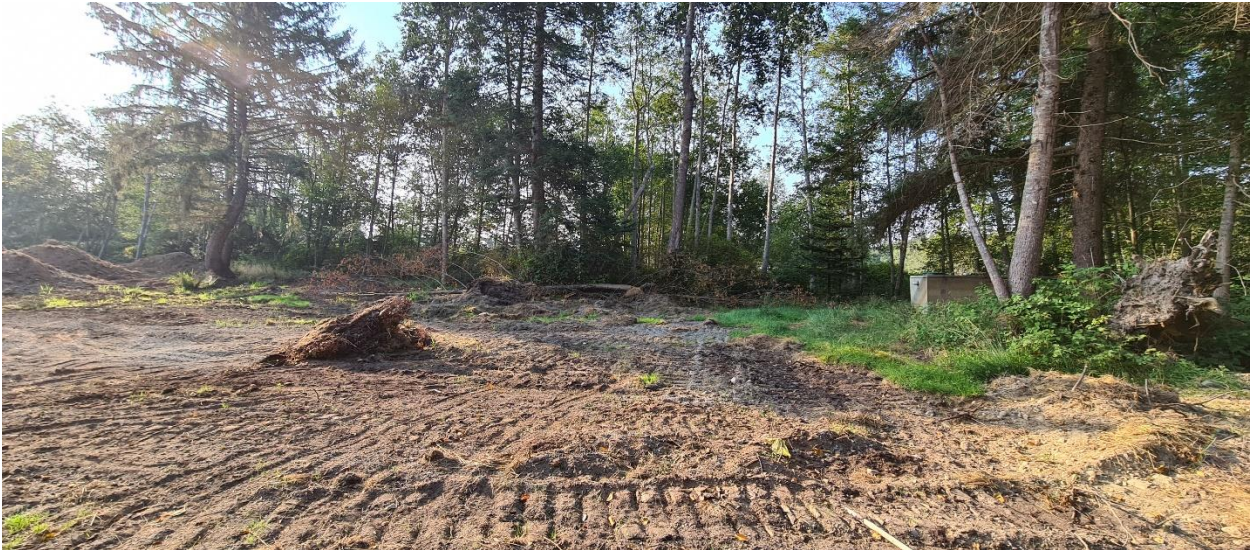
Rear area of fill

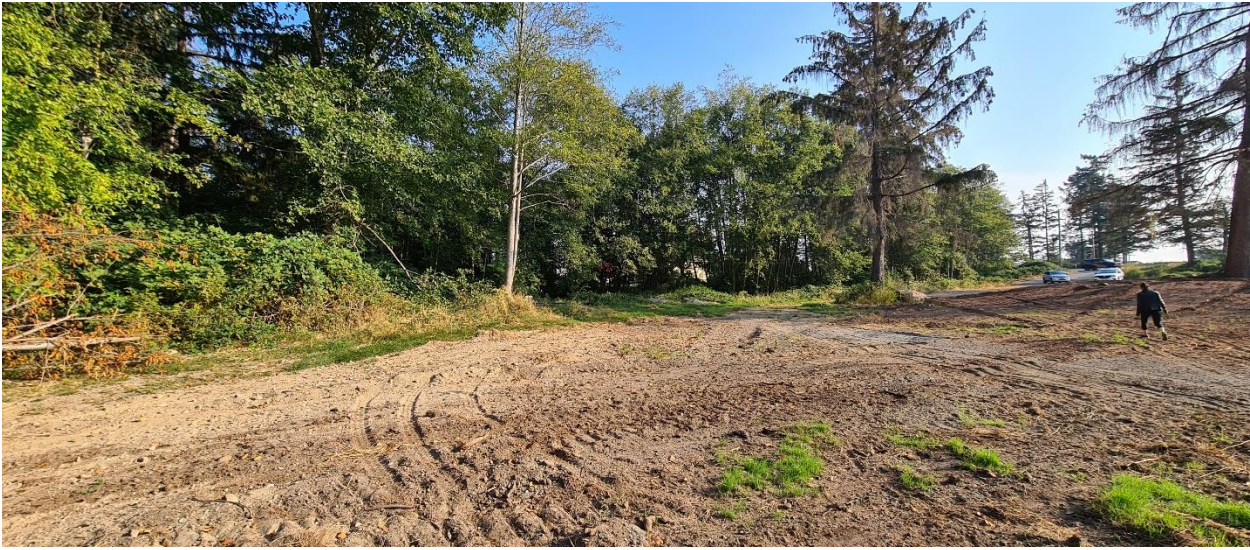
Fill area looking east

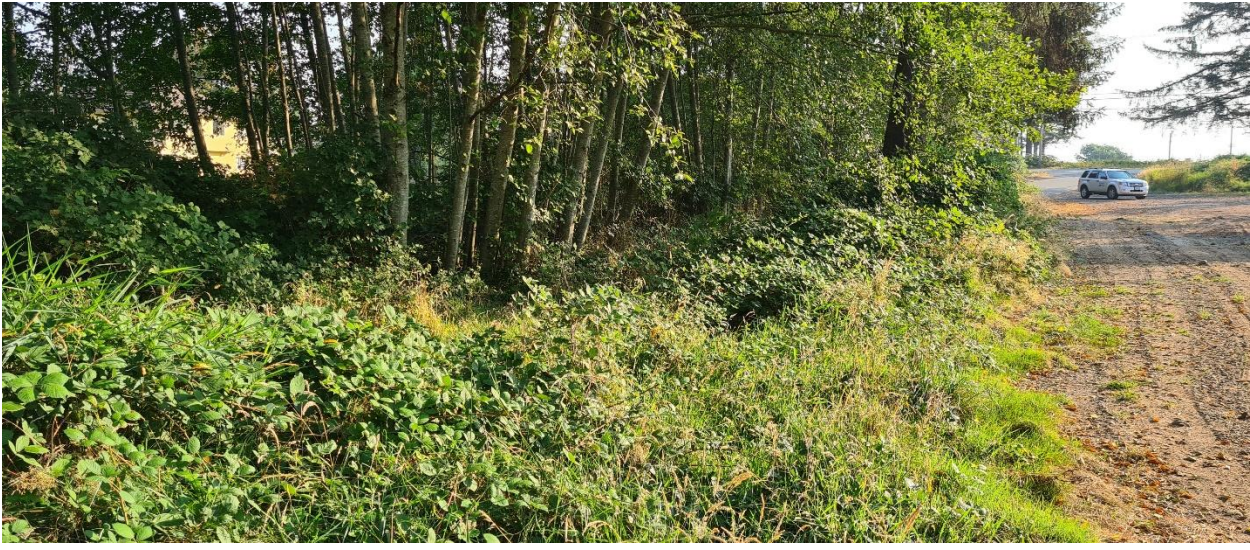
SPEA along North boundary

- i) Prior to the commencement of development, the 18-metre Streamside Protection and Enhancement Area (SPEA) must be clearly flagged or staked to protect the vegetated area of the SPEA from encroachment.
- ii) The project biologist is to be notified three days prior to beginning construction so that site documentation of development can occur.
- iii) No construction, land altering activities including gardening is to take place within the vegetated area of the 18-metre SPEA. A suitable fence (such as split-rail) is to be constructed on the SPEA boundary to prevent future encroachment.
- iv) During construction, exposed soils outside of the work area are to be covered with straw and/or mulch to prevent sedimentation of the watercourse.
- v) A post-construction site inspection will be required to ensure that the SPEA has been protected.

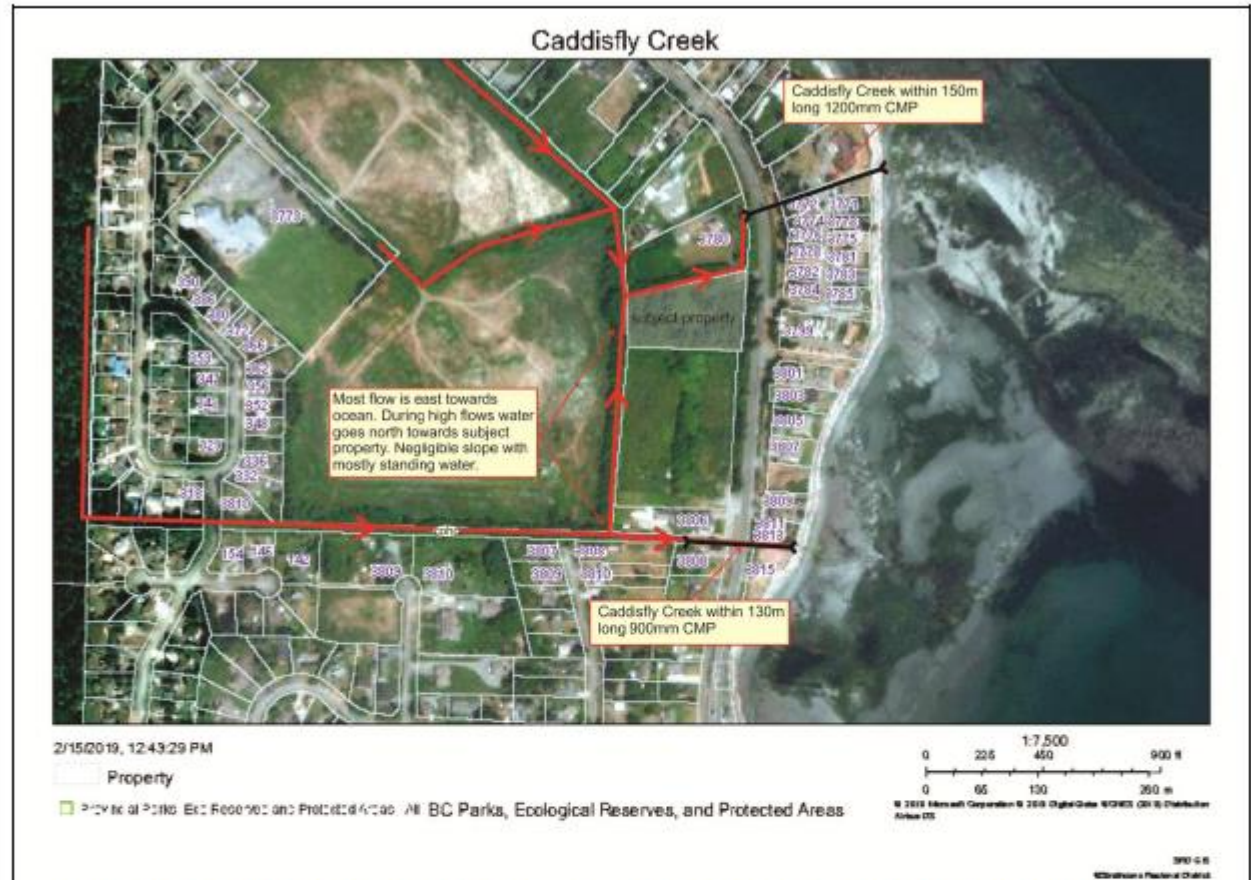
Figure 1, Location of subject property and Caddisfly Creek with direction of flow shown.

The main stream channel flows within a 900mm corrugated metal pipe (CMP) culvert for 130m from Highway 19A connecting directly to the ocean. During high flows Caddisfly Creek flows within a divergence channel to a secondary channel along the north property boundary of the subject property and crosses the highway and the downslope residential area through a 150m long 1200mm CMP. Upstream of the highway, the streams are entirely within ditches/channelized (Figure 1), linear in nature with poor habitat complexity in the vicinity of the property. In general, much of the watershed appears to be in a similar condition, all streams appear to have been ditched/channelized.

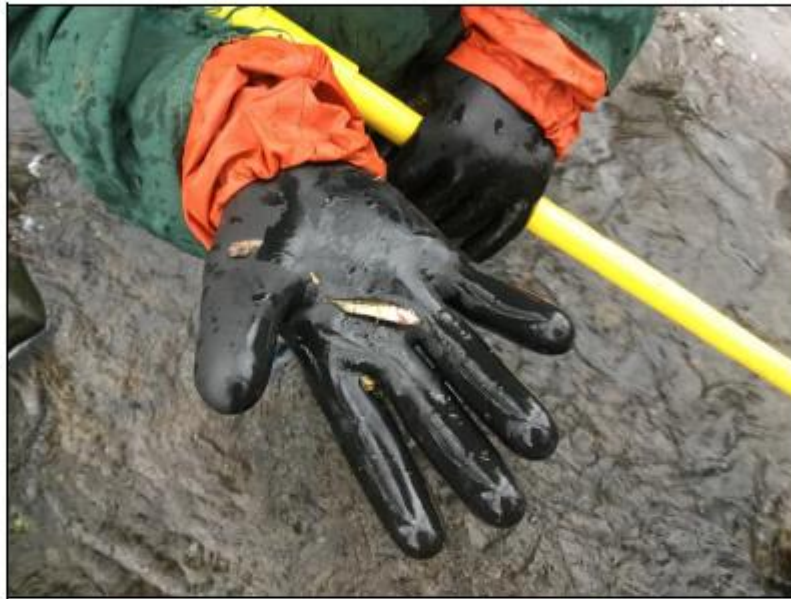
Label Photo 1: View of a stickleback located in Caddisfly Creek tributary near the end of Mittenatch Drive.

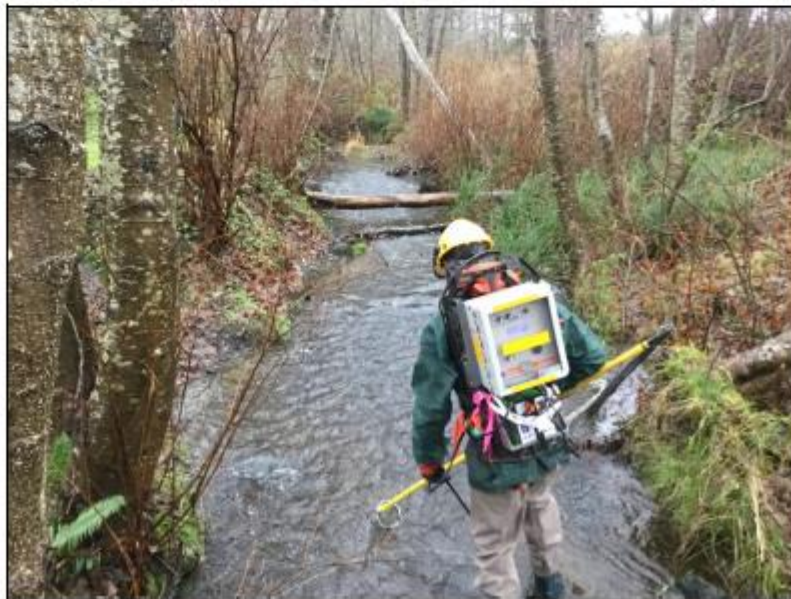
Label Photo 2: View of channelized Caddisfly Creek tributary west of the end of Mittenatch Drive.

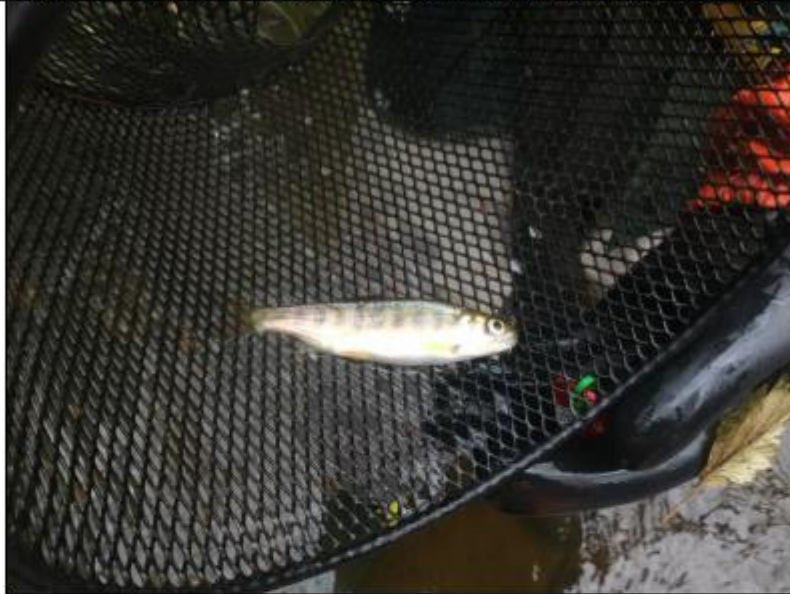
The required sampling permits were acquired and sampling was conducted on December 13, 2018. Water flows were medium and the instream water temperature was 6.5C. An unnamed tributary of Caddisfly Creek that drains along the vacant property between the end of Mittlenatch Road and Stuart Place was sampled using a Smith-Root backpack electrofisher and Gee type minnow traps using dry cat food as bait. A stickleback (Photo 1 - this species is not recognized as fish under the RAR) was located readily (11 electrofishing seconds). Sampling continued and numerous stickleback were sampled. A coho salmon smolt was sampled after 620 electrofishing seconds. Sampling was conducted within this channel as it provided the best quality potential salmonid habitat (te stream is 2-3m wide, better stream flows with predominantly gravel substrate with some fines/cobble) (Photo 2). Sampling ceased once the coho was located. There is limited spawning habitat for coho salmon within the channel to the south of the property where the coho smolt was located (Photo 3).

Label Photo 3: A coho salmon smolt was located in the Caddisfly Creek tributary.

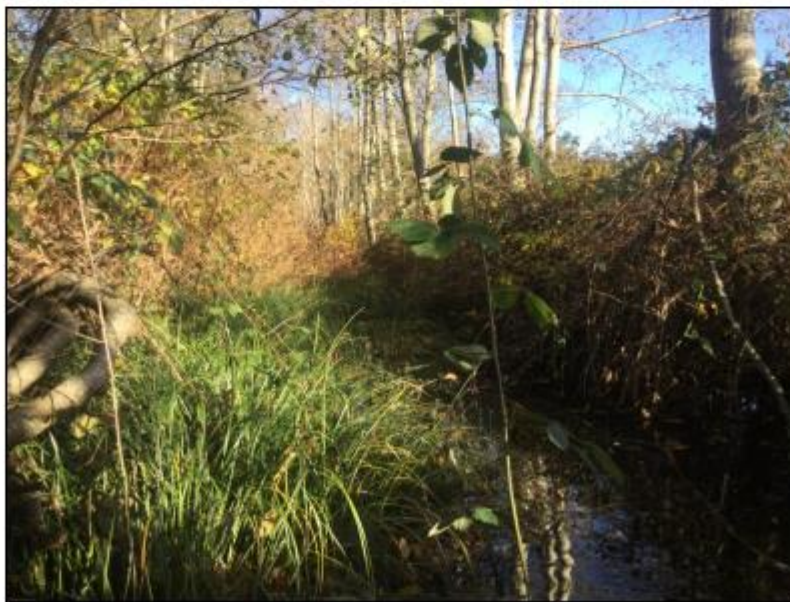
Where the channel flows north towards the subject property and adjacent to the property itself, the substrate is 100% fines/mud with a 0-1% gradient and is completely glide habitat. It has been confined within a wide shallow swale between 6 and 8m wide with poorly defined stream banks. This

Label Photo 4: View of the channel flowing north towards the subject property.

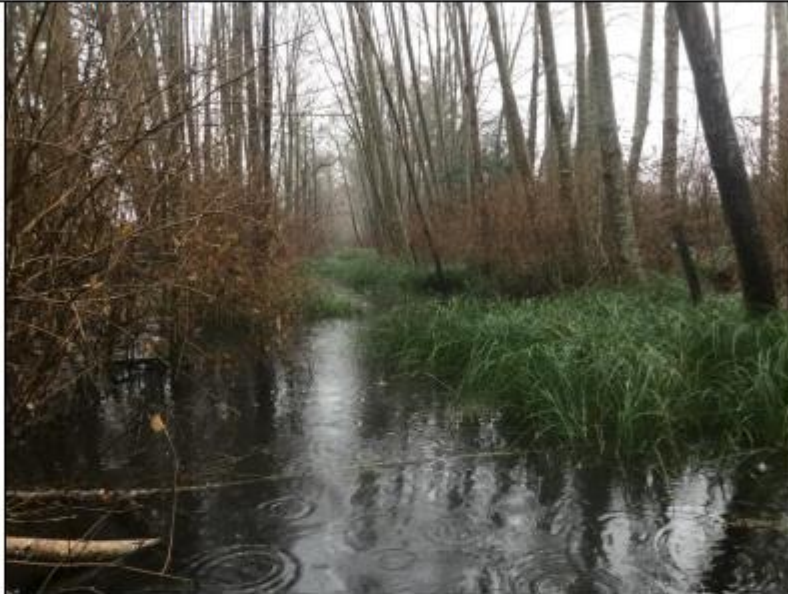
Label Photo 5: View south of stream adjacent to the property from the north/west corner. It is confined within a wide ditch.

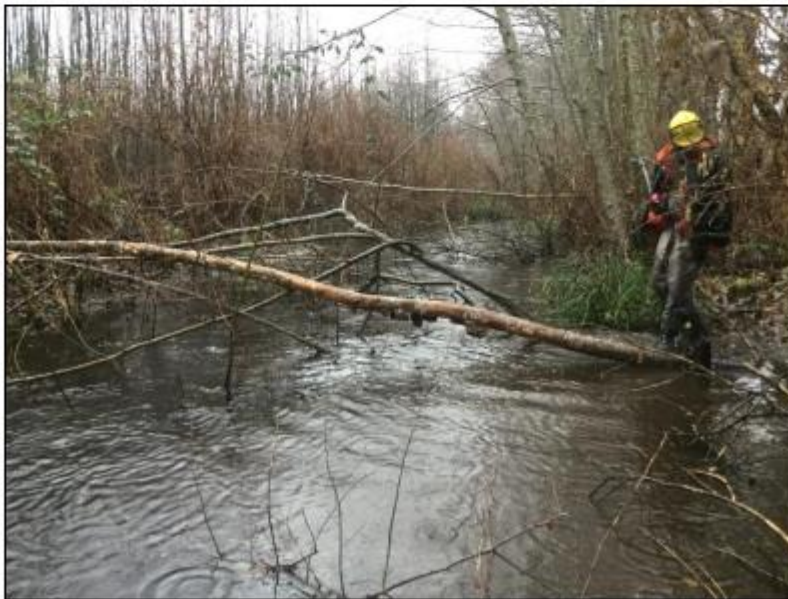
Label Photo 6: View east of stream adjacent to the property from the north/west corner.

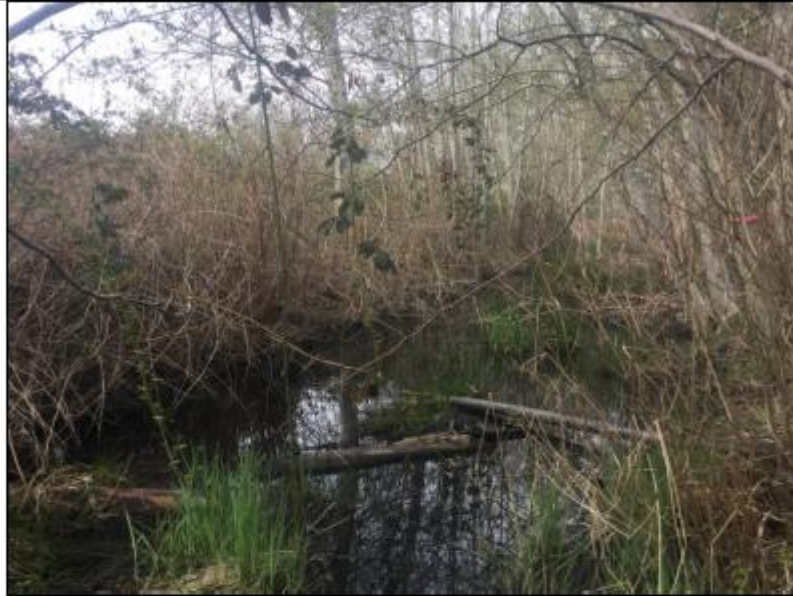
There is a low lying ditch/swale along the south side of the property. The ditch is shallow with a fines substrate that holds water during the winter due to the high water table in the area. The ditch varies between being a wide swale with sedges at the top near the highway (Photo 7) to a narrow confined ditch <1m wide (Photo 8). It does not appear to ever have much flow. There is no access for fish from the west ditch into the south ditch due to poor connectivity between the two ditches (Photo 9). The south ditch has no slope and consists of standing water at the level of the water table on the property. The ditch does dry completely during periods of low precipitation. Fish sampling within the ditch was conducted April 17, 2019 to confirm the ditch as non-fish bearing. Sampling for 290 electrofishing seconds in the south ditch did not locate any fish. Stickleback were located in the north ditch, but no fish were located in the west ditch in the vicinity of the confluence of the south ditch or south of that point for approximately 100m (215 additional electrofishing seconds).

Photo 7: There is a low lying ditch/swale on the south side of the property. It is shallow with a fines substrate that holds water during the winter due to the water table level in the area. It varies between being a wide swale (photo) with sedges at the top to a narrow ditch.

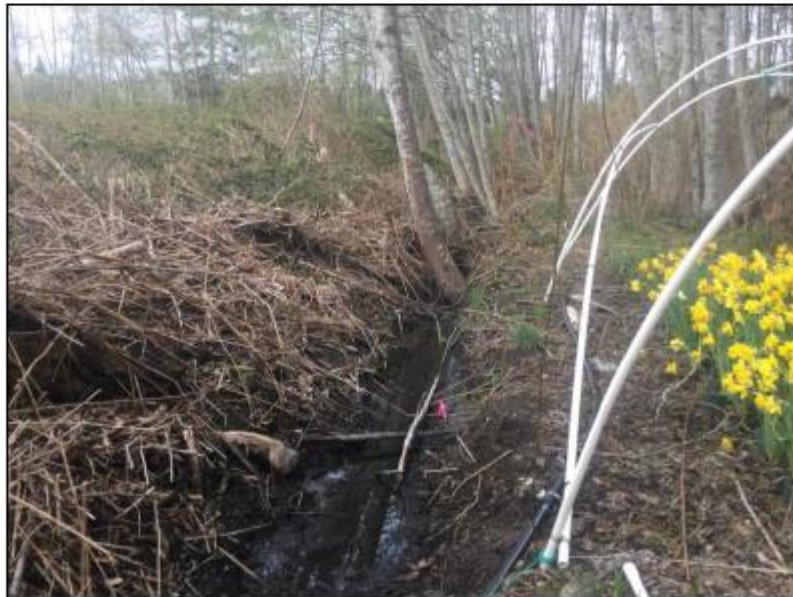
Photo 8: There is a low lying ditch/swale on the south side of the property. It is shallow with a fines substrate that holds water during the winter due to the water table level in the area. It varies between being a wide swale with sedges at the top to a narrow ditch (photo).

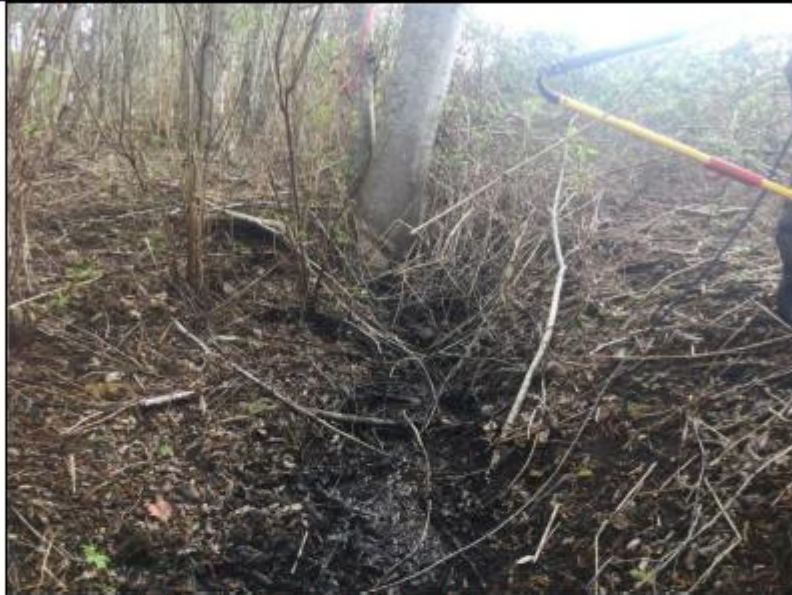
The south ditch is a low lying area with very little flow which has water in it based on the surrounding water table. There is no access for fish into it and it does not provide suitable habitat for fish and is considered non-fish bearing with a SPEA of 2m.

Photo 9: There is no access for fish from the west ditch into the south ditch due to the shallow overland flow over the west ditch sideslope and a mature alder tree growing in the bottom of the ditch.

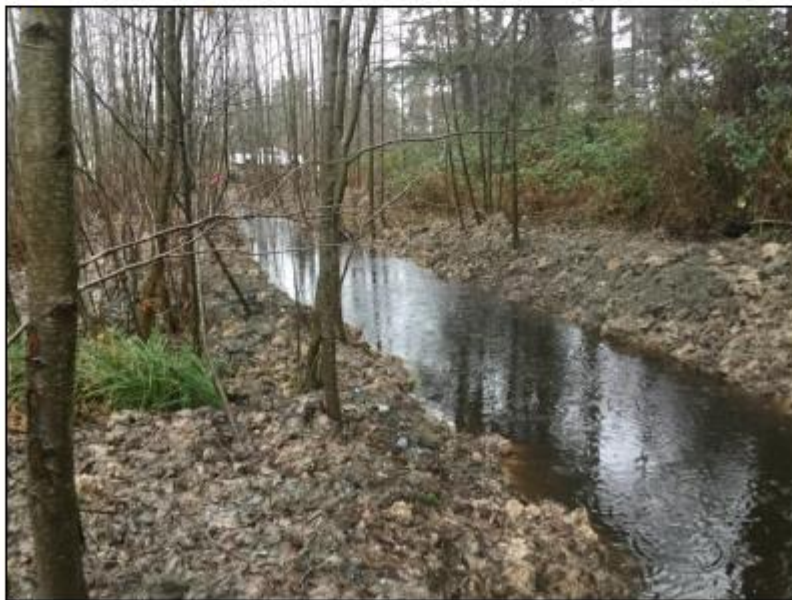
Two trenches for services were excavated in 2018 that infilled with water when the water table rose (Photos 10 and 11). The intention will be to fill both trenches once site conditions allow as they are not functioning as ditches and are not intended to be ditches. The original south ditch will be retained as it is.

Photo 10: There is a newly cut ditch that will be filled in. The works must be done when the ditch is dry.

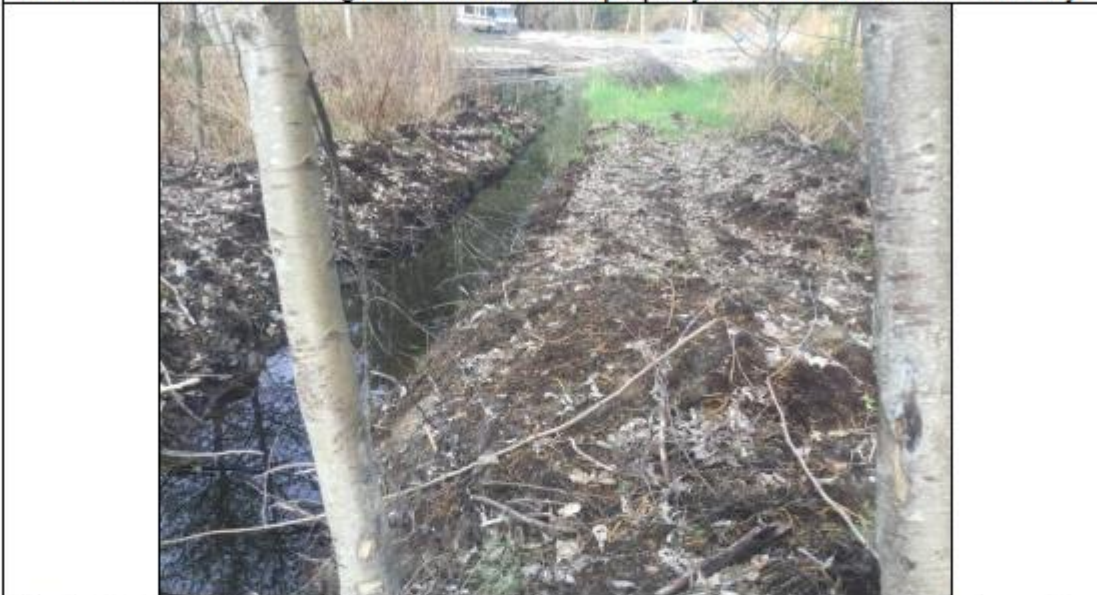
Label Photo 11: A trench was dug in the middle of the property which will be filled in when dry.

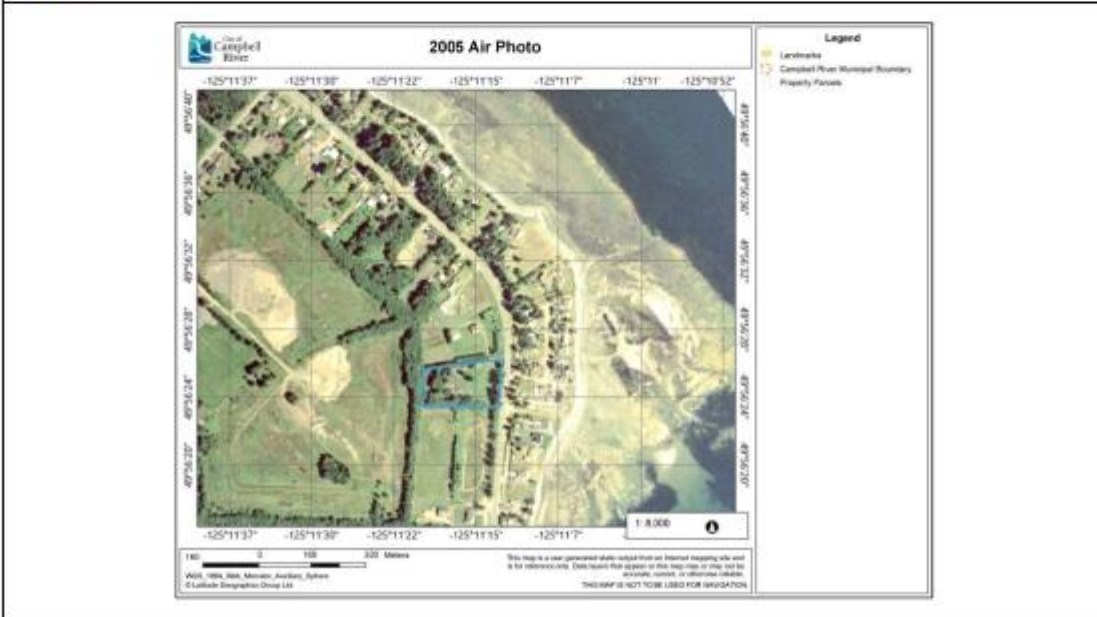
Label Photo 12: Air photo from City of Campbell River showing property was mostly cleared in 2005.

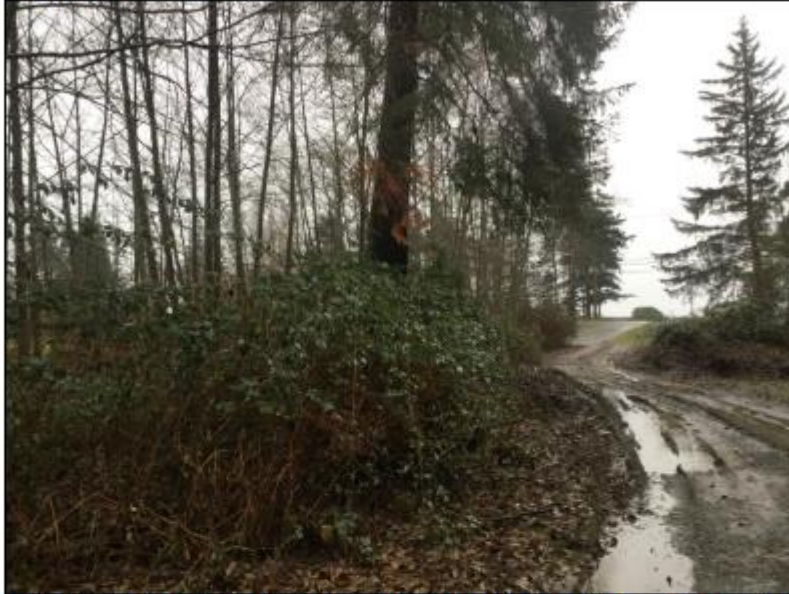
At the time that the property was acquired it was in a disturbed state. There was rubble/fill deposited south of the easement (driveway for the neighbouring property to the north). The site had been mostly cleared in 2005 (Photo 12) and has since infilled in dense blackberry. The riparian area immediately adjacent to the channel is vegetated predominantly in red alder and Himalayan blackberry with sedges growing within the channel. There are scattered mature second growth trees throughout the property and riparian area including western red cedar, red alder and big leaf maple (Photos 13-14).

Label Photo 13: View east towards highway showing current access to the property. Stream is to the left of the photo. View of scattered older trees. The driveway will be moved and the SPEA vegetation restored.

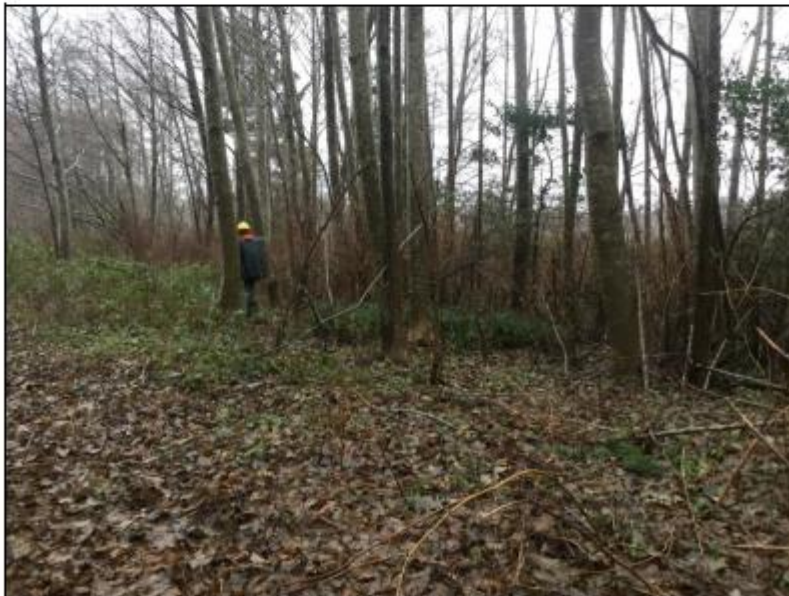
Label Photo 14: View of riparian area along the west side of the property. The understory vegetation is difficult to see due to the time of year. Predominant vegetation is alder along the channelized stream.
